Manhole Inspection Summary

Manhole # S45EE_044MH

Insp Date: **12/20/07 11:54 AM**

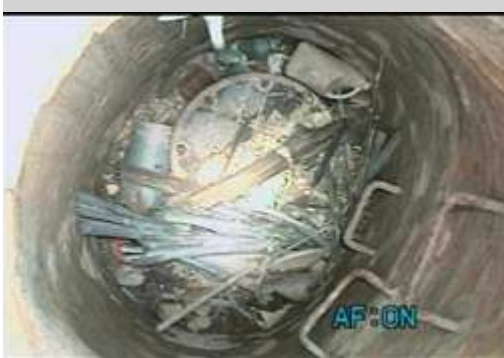
Defect 1

Condition: ☐ Sound ☐ Cracked ☐ Root Intrusion ☐ Deteriorated ☐ Leaks ☒ **Debris**

Steps Count: **4** Missing: **0** ☒ **Corroded**

steps corroded, channel cond debris

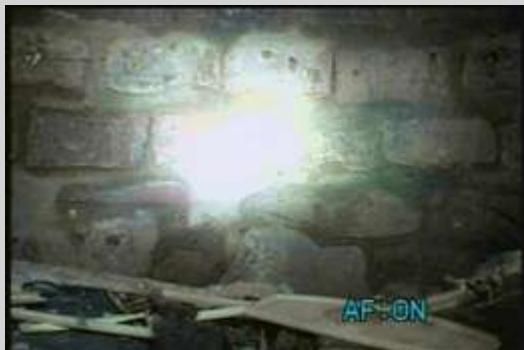
12 O'Clock Outflow

8 in. Circular Gravity Sewer
Pipe Out @ 12 O'Clock

pipe out is in center of image, covered by debris

Deposits: ☐ None ☐ Mud ☐ Sludge ☒ **Debris** ☐ Grease

Silt Depth: **8** (in.) Deposits Extent: **Heavy**
